# Effects of Impurities on the Degradation of SOFC Stacks

T. Horita, H. Kishimoto, K. Yamaji,  
M. E. Brito, H. Yokokawa

*Fuel Cell Materials Group, Energy Technology Research Institute  
E-mail: [t.horita@aist.go.jp](mailto:t.horita@aist.go.jp)*

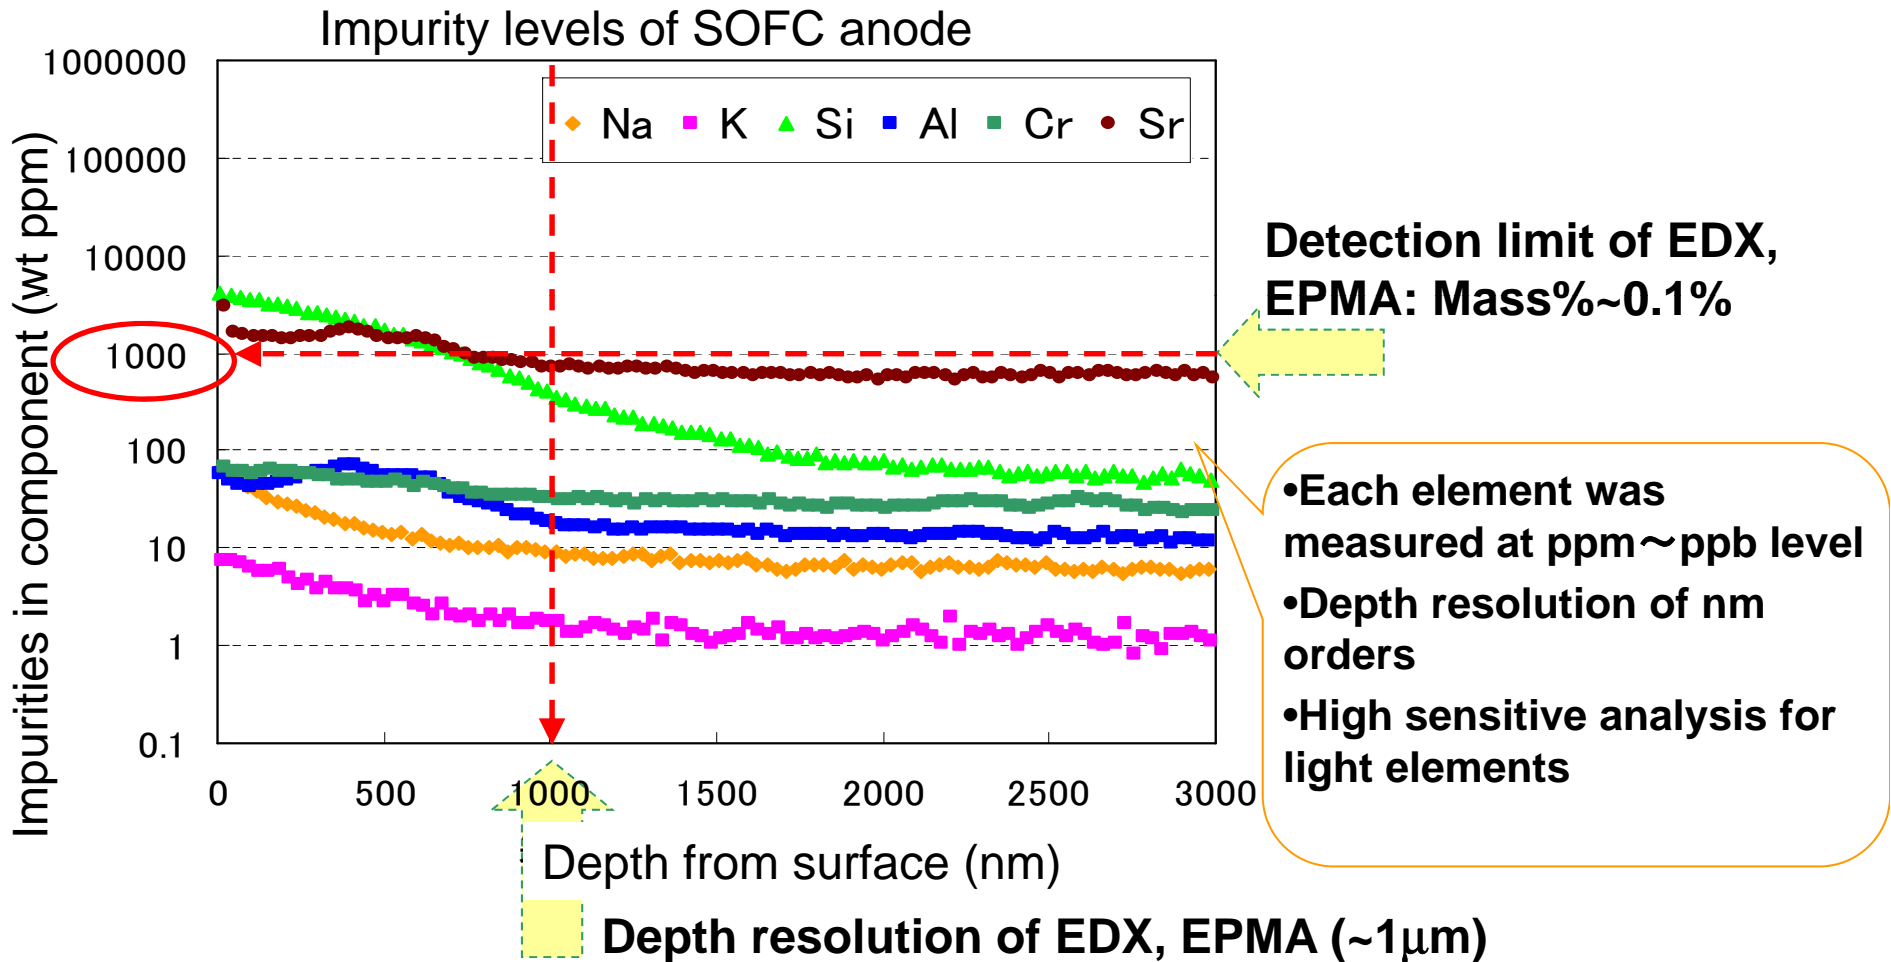
# Example of impurity level analysis by SIMS

Key point: High sensitivity for light elements and depth resolution

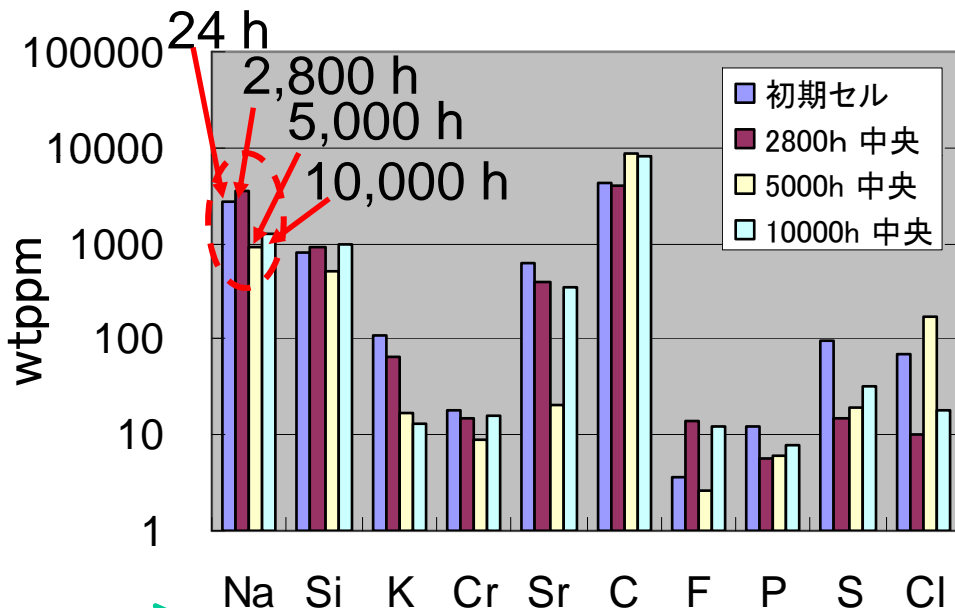
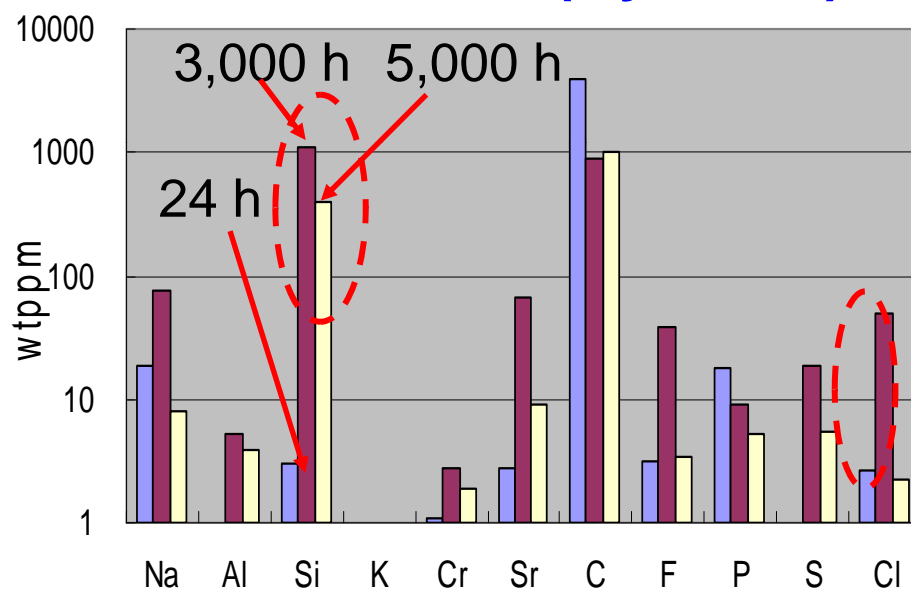
## Segmented in-series (MHI)

## Flatten tube (Kyocera)

Impurity elements

1. The impurity level is different depending on the stack/modules
2. The increase of Na, Al, Si concentration can be due to the thermal insulators

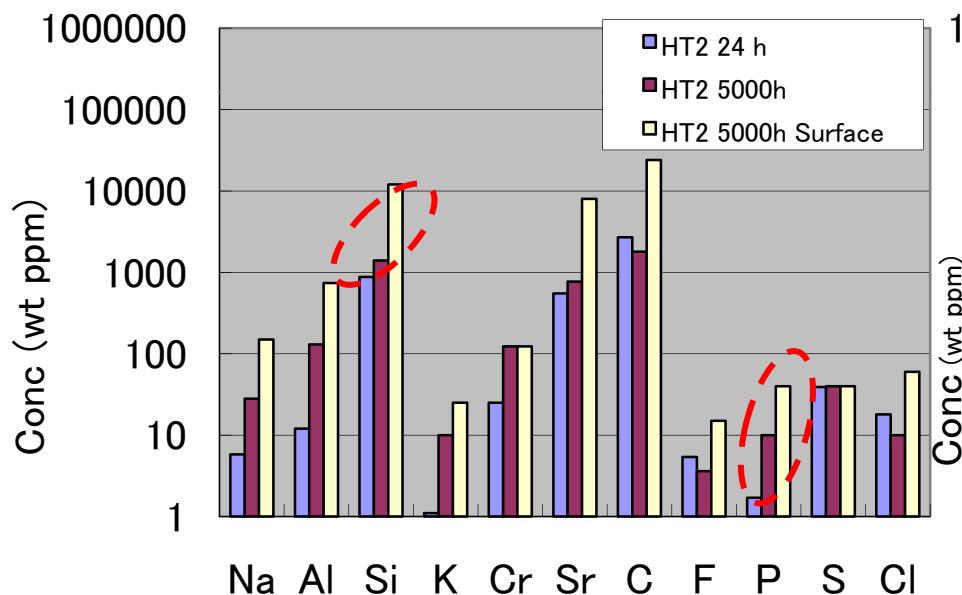
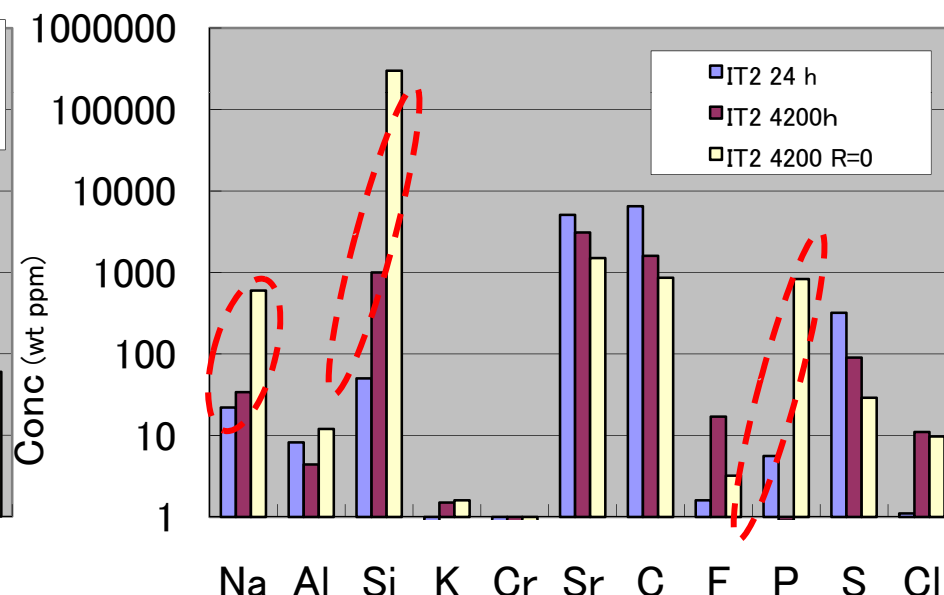
## Tubular (TOTO)

## Disk type (MMC)

1. A significant increase of Na, Al, Si, and K concentrations,
2. C, S, P and Cl and some other elements show strange behaviors.

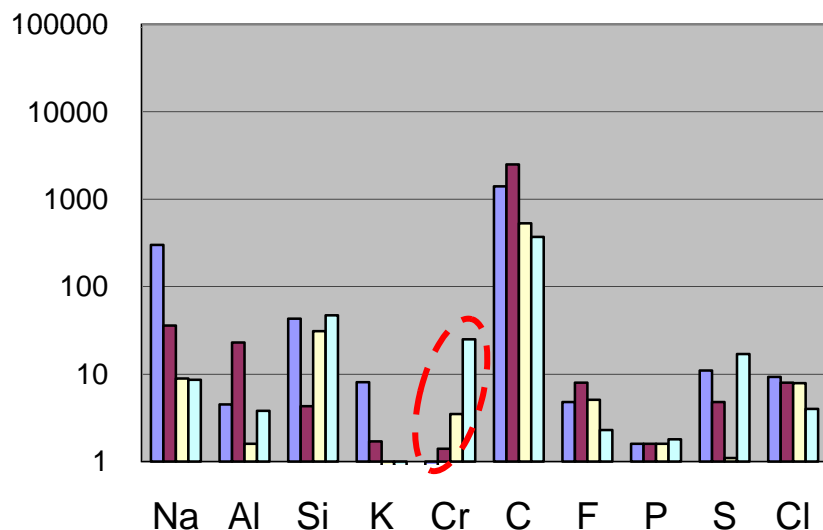
Segment in Series (Cathode)

Impurities of Al, Si, Cr are increasing with time  
Exposed in air side and easy to deposit impurities from air

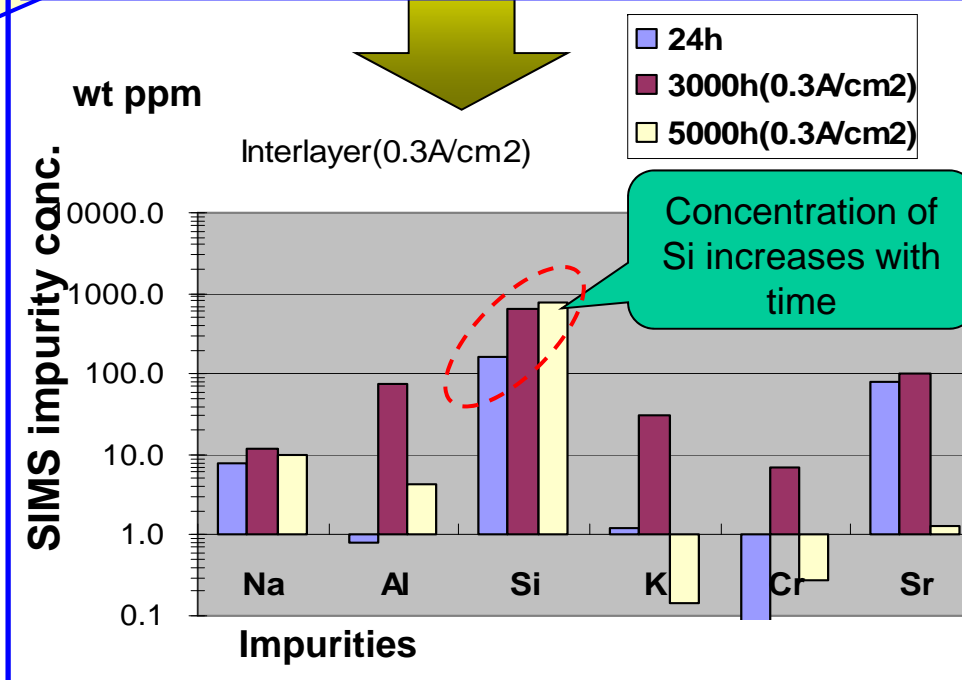
Concentration level change was determined in ppm level by SIMS

Impurities of **Interlayer** around Cathode/Electrolyte Interface

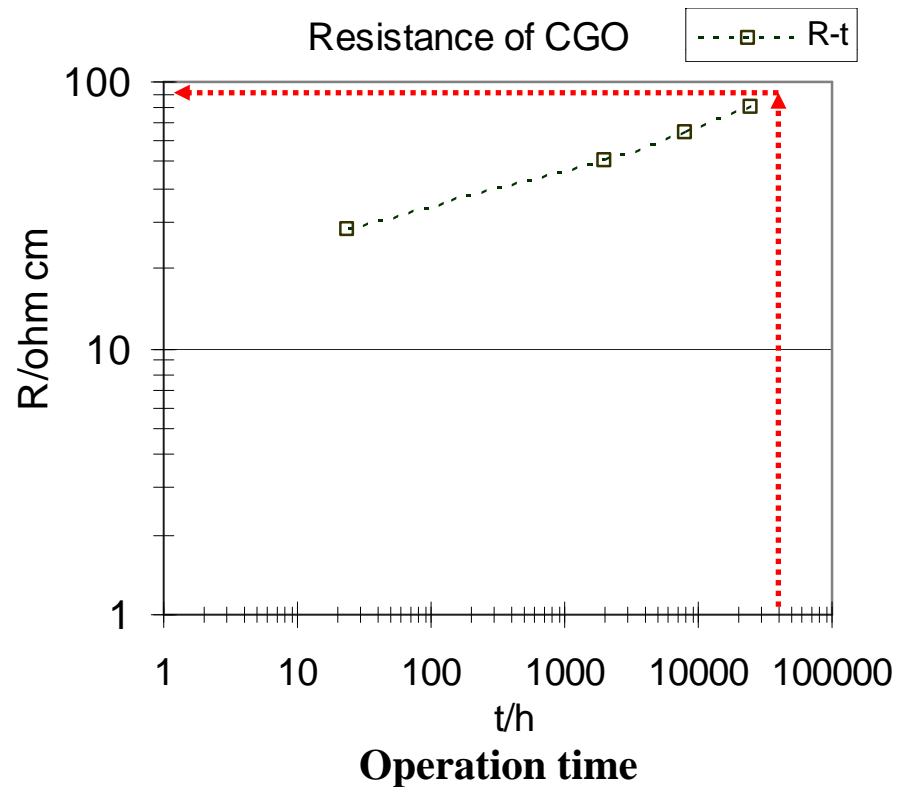
## Resistivity change by Si in GDC

(linear increase of Si-concentration and resistance)

Resistance of GDC interlayer after 40000 hour: 90  $\Omega\text{cm}$  (3 times of initial)

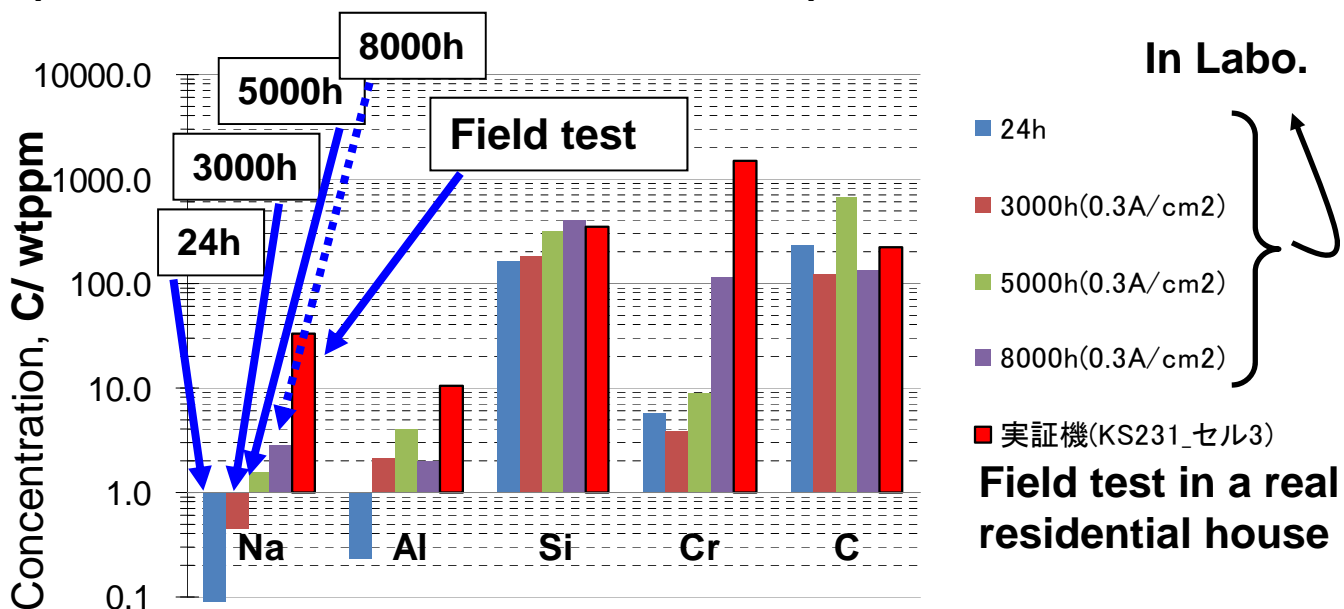
**High sensitive analysis for impurities: cathode**  
( field tested for more than 3500 h )

- Left 4 bars indicates the concentration in Labs
- Higher concentration of Na,Al,Si,Cr in the field test

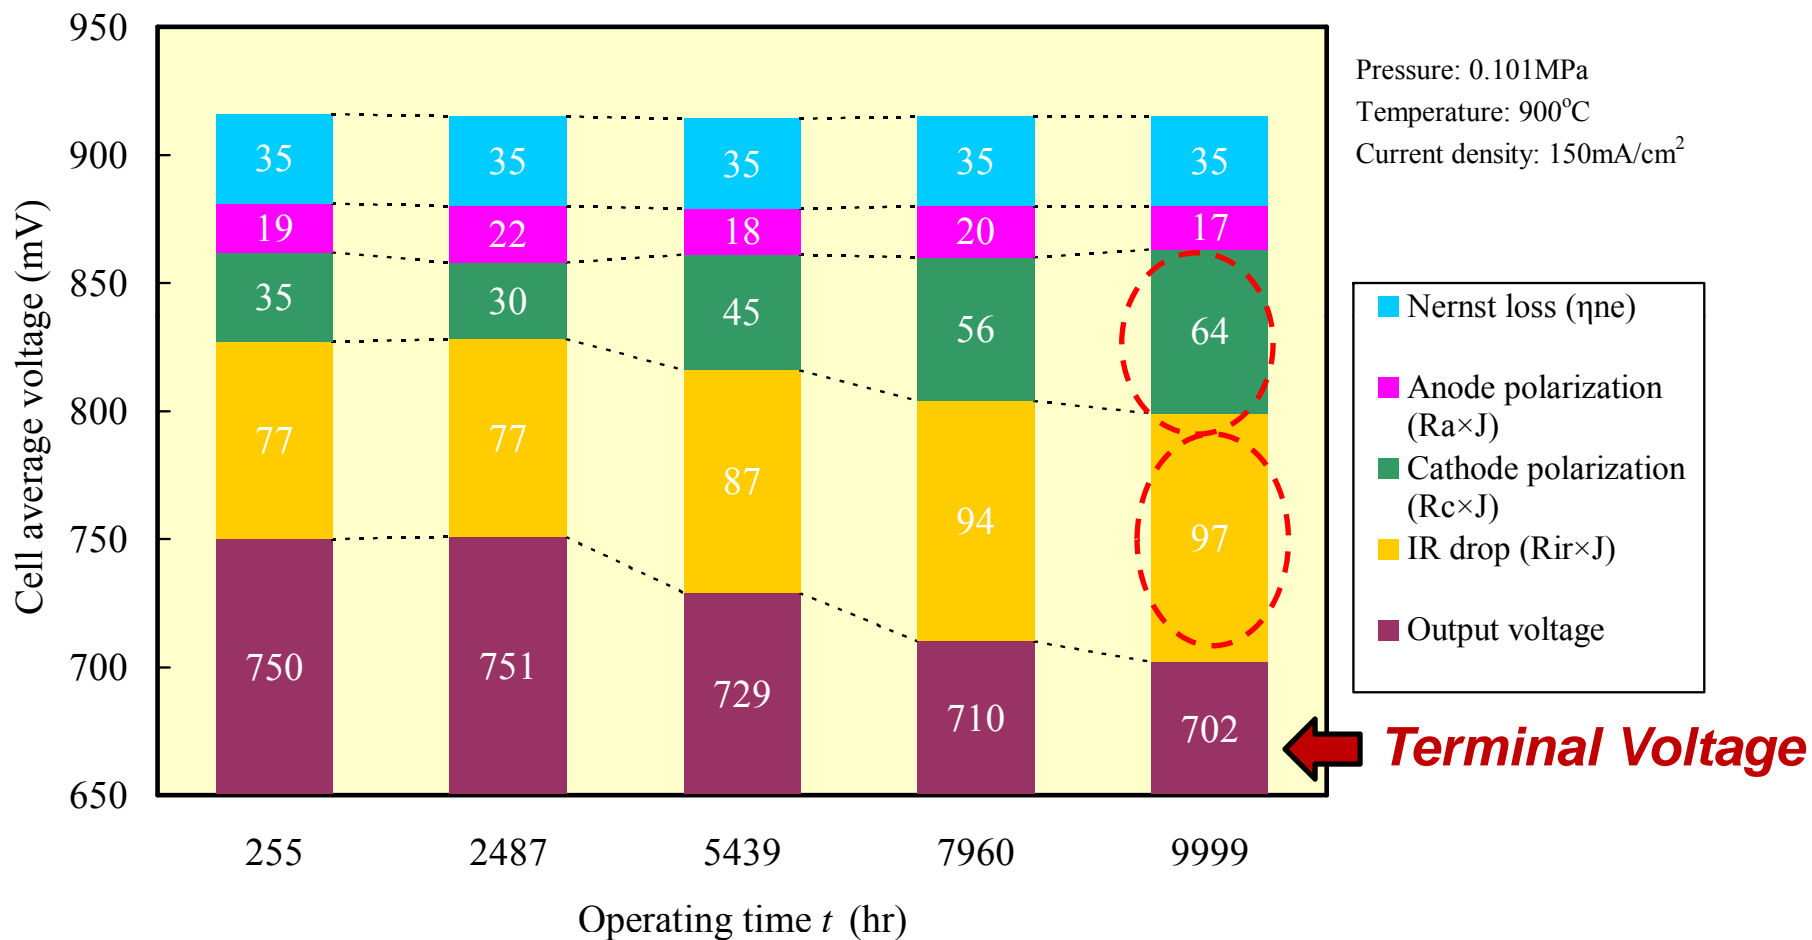
# Electrochemical performance analysis: Segmented in-series stack (by CRIEPI)

Cell degradation is due to the 1)IR drop and 2)cathode polarization

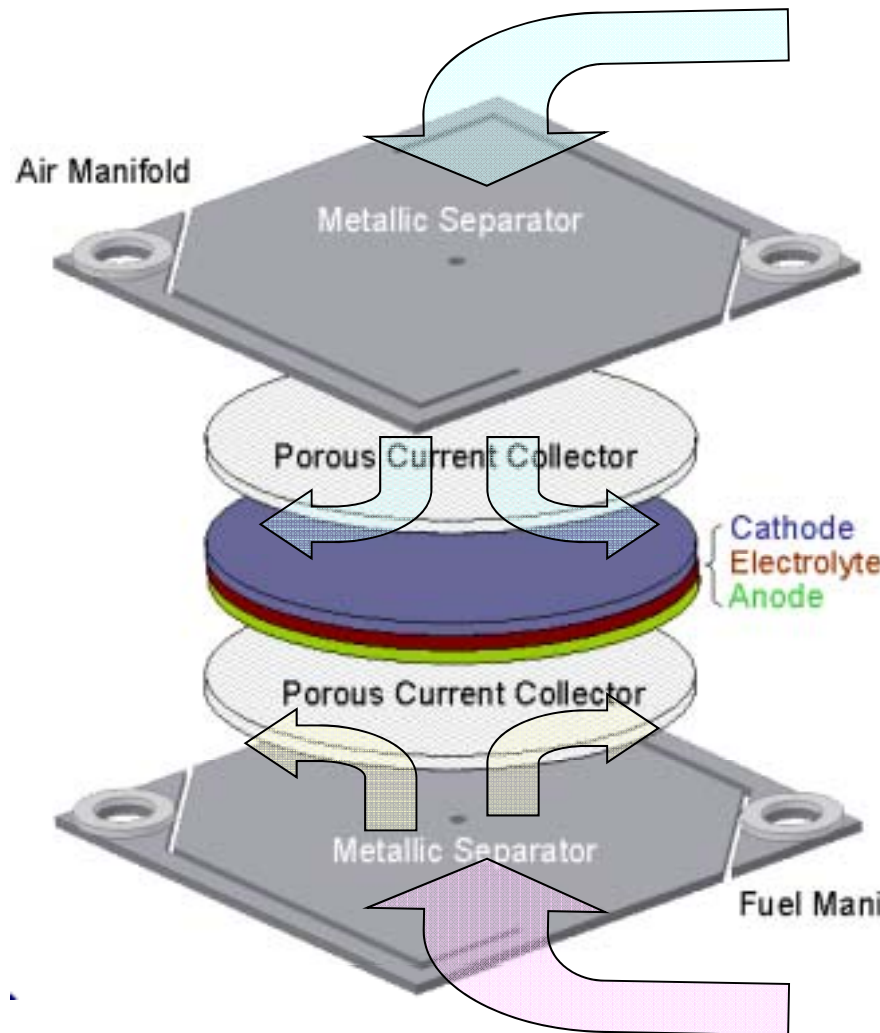
# Impurity analysis: Disk planer type

Air  
(impurities: P, S, Cr)

Fuel  
(impurities: S, Cl, Ca, Na, Si)

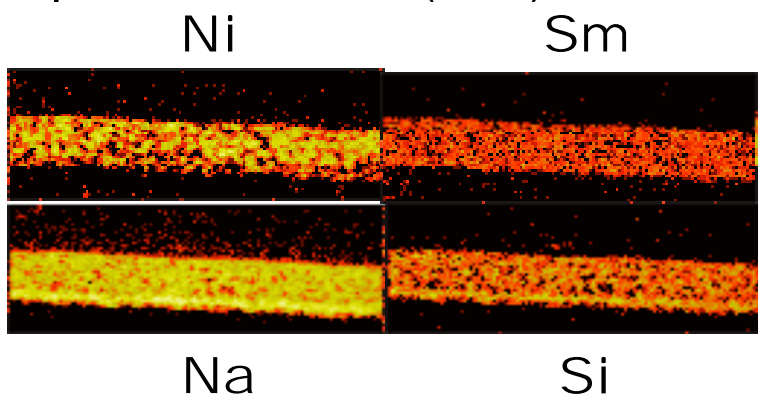
## Center of Anode: Concentration of Na and Si

Operation: 4200h (R=0)

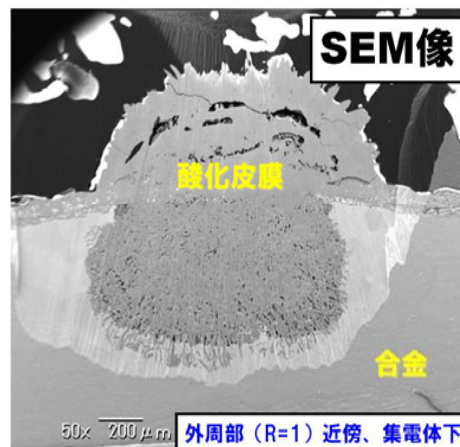
## Anomalous Oxidation of IC

The formation of anomalous oxide scale was improved by coating.

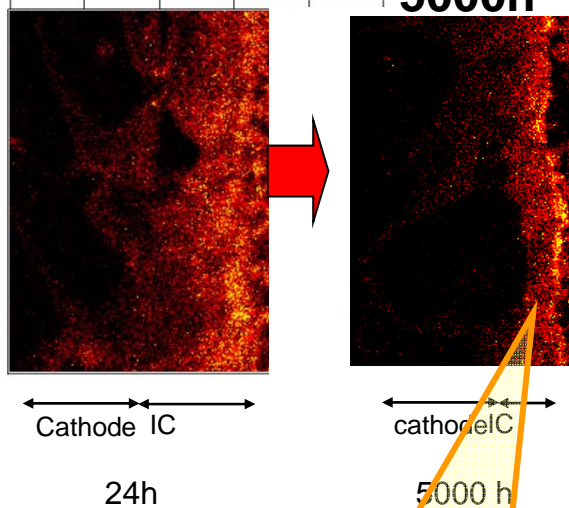
### SIMS image of Ca

Increase of Ca concentration

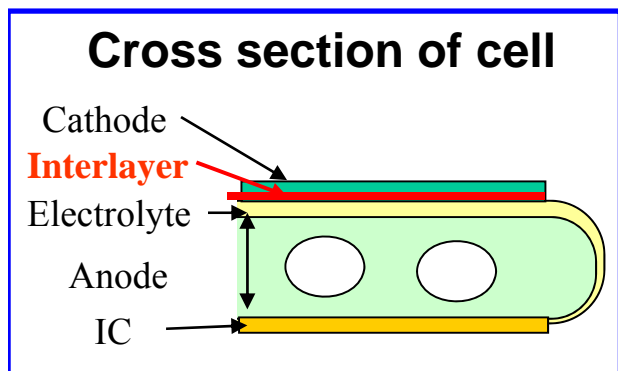
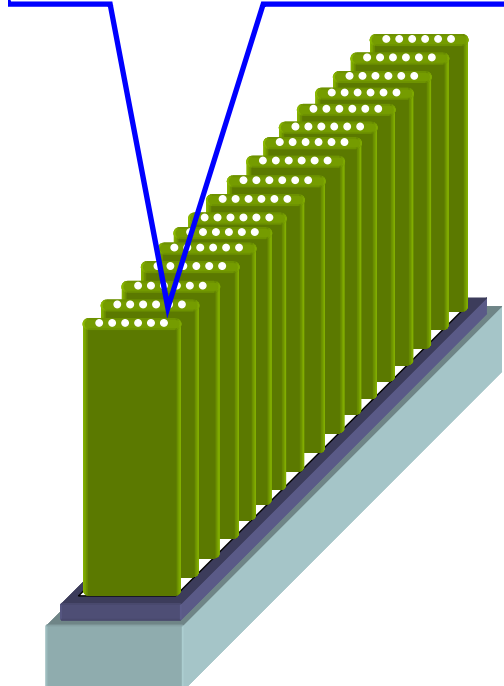
SIMS images of cathode/interlayer/electrolyte

High Sr concentration in  $\text{CeO}_2$ , but no diffusion in YSZ

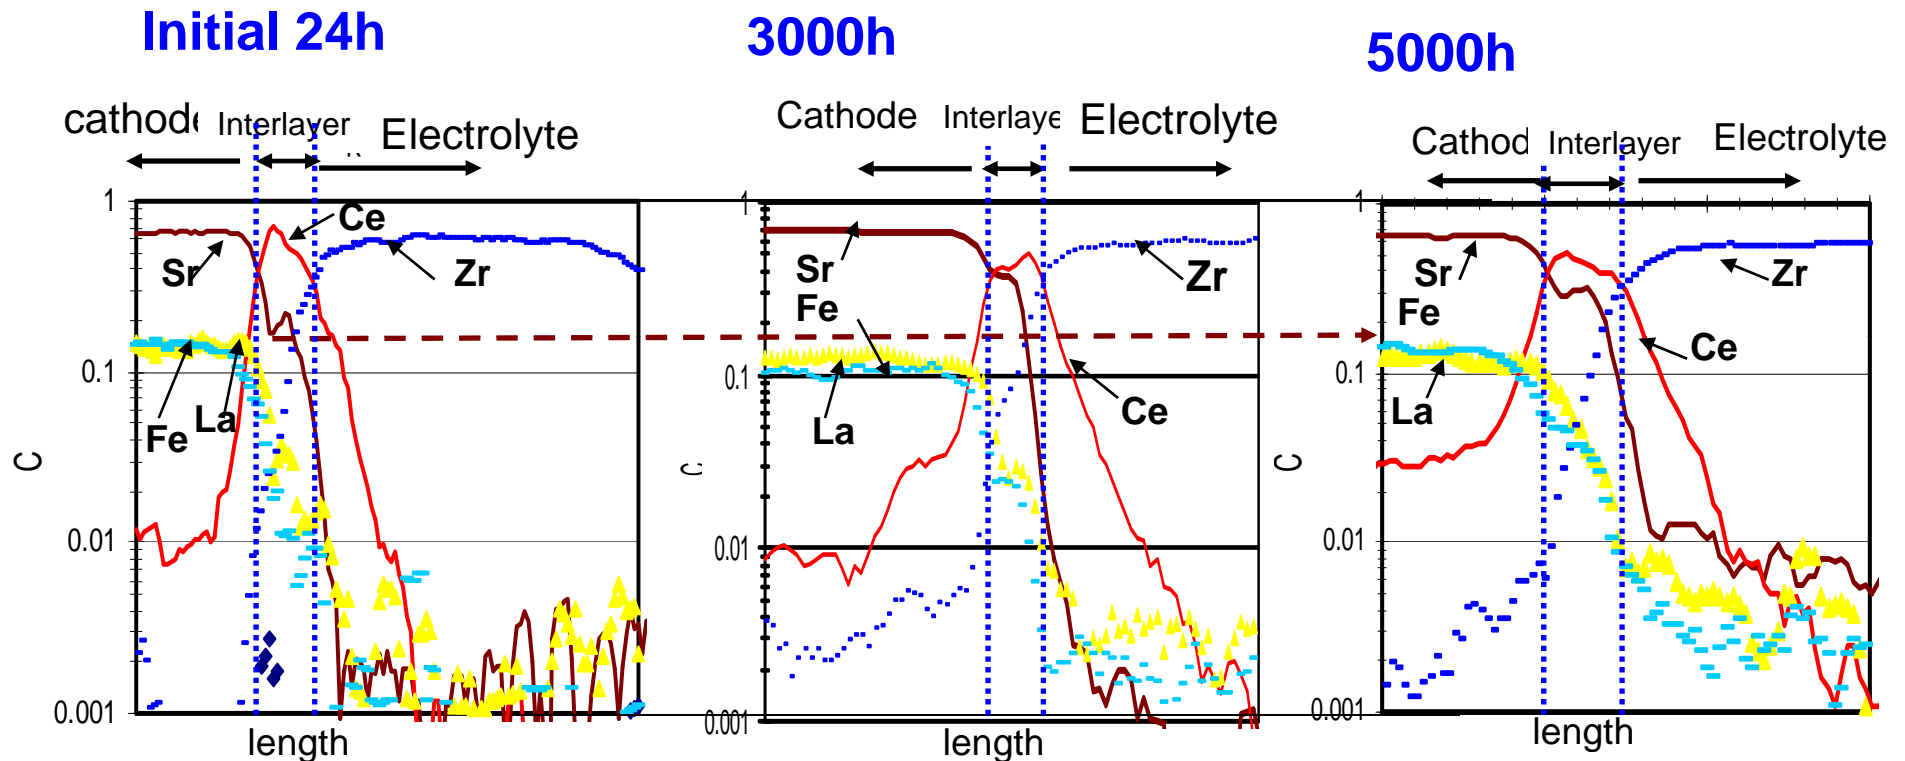
# SIMS Line scan for cathode/electrolyte Interface of Flat-tube stacks operated at $0.3 \text{ Acm}^{-2}$

## Compared with Initial state

- Sr content increased in  $\text{CeO}_2$  interlayer.
- Although Sr level increased in electrolyte, no apparent  $\text{SrZrO}_3$  formation.

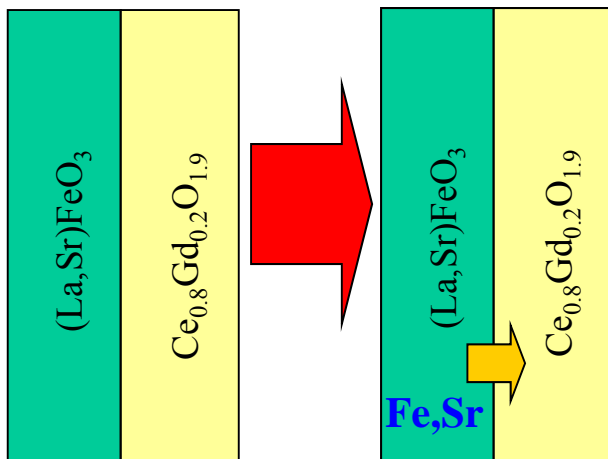
## Annealing of diffusion couple

Initial **1100°C** Over 100h After diffusion

Diffusion phenomena:

- 1) Formation of  $\text{GdFeO}_3$ ,
- 2) Grain boundary diffusion of Sr, Fe
- 3) Fast elemental diffusion

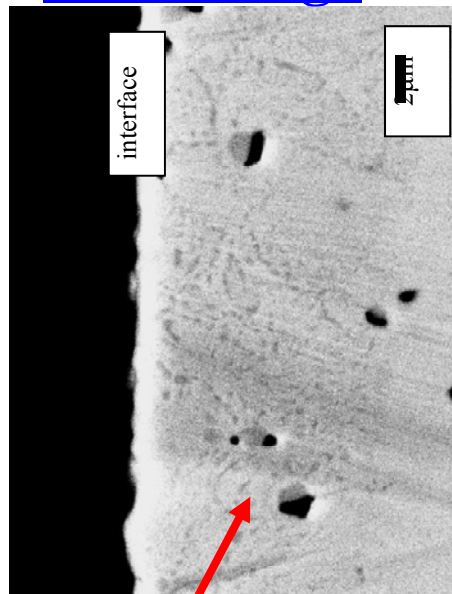
## SEM image

Fast diffusion of Fe
